Newsflash 6, April 1997.
Section: Disinfection. No. 1.

Hospital experiments on the prevention and removal of scale in sterilizers using “**Scalewatcher**[™]”

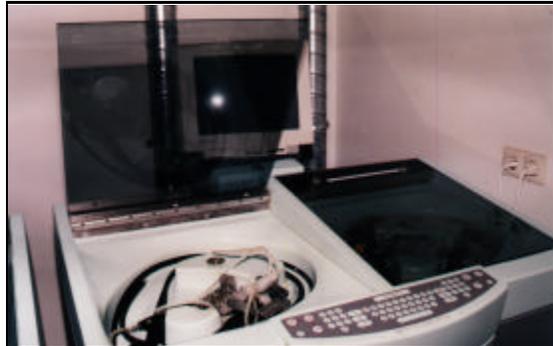
The hospital uses sterilizing equipment (picture 2 and 7) to disinfect its endoscopes. Scale deposits were clogging the small sprinkler openings in the sterilizers. (Pictures 3, 4 and 5)

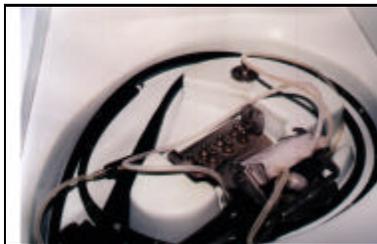
Prior to use, the endoscopes are tested for leaks in the Sterilising Unit (JW2200), manufactured by Dyped in the Netherlands. Picture 3 shows the JW2200 in the enclosure. When it is confirmed that there are no leaks in the equipment, the endoscope is rinsed through with soap and water, which also establishes whether there are any blockages in the equipment. Air is pumped through to remove any traces of soap from the apparatus. The endoscope is then thoroughly cleaned with disinfectant and is rinsed twice. The tank is emptied and all tubes are cleared. A computerised system controls the process. The disinfecting unit is self-regulating and in addition to controlling both the water and disinfectant it is also capable of automatic thermal disinfection.

The element inside the sterilizer continually scaled-up, necessitating regular maintenance to keep the machine fully operational. Scaling was occurring in the boilers being used to heat water for the thermal self-rinsing as well as the washing equipment. This caused choking up of the sprinkler openings and poor water temperature control. The unit was therefore not working effectively, which not only led to increasing energy costs but could result in the endoscopes not being fully sterilized. Picture 3 shows a rinsing unit with an endoscope around it.

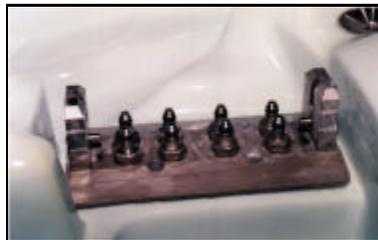
4

An inspection two months after the **Scalewatcher™** system was installed, showed the new unit (B) was completely scale free whilst in the older unit (A) (picture 4) far less scale was visible. Unit C (picture 5) showed an increasing scale build-up as usual. An inspection six months later showed even a better result and it was concluded that the experiment was a success.

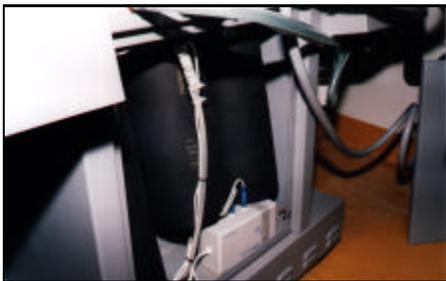
The **Scalewatcher™** Commercial was attached to 15 mm (0.6 inch) diameter tubes. (Picture 6)
